2.16 INTERFERENCE FRINGES OBSERVED IN WAC FLAT FIELD IMAGES

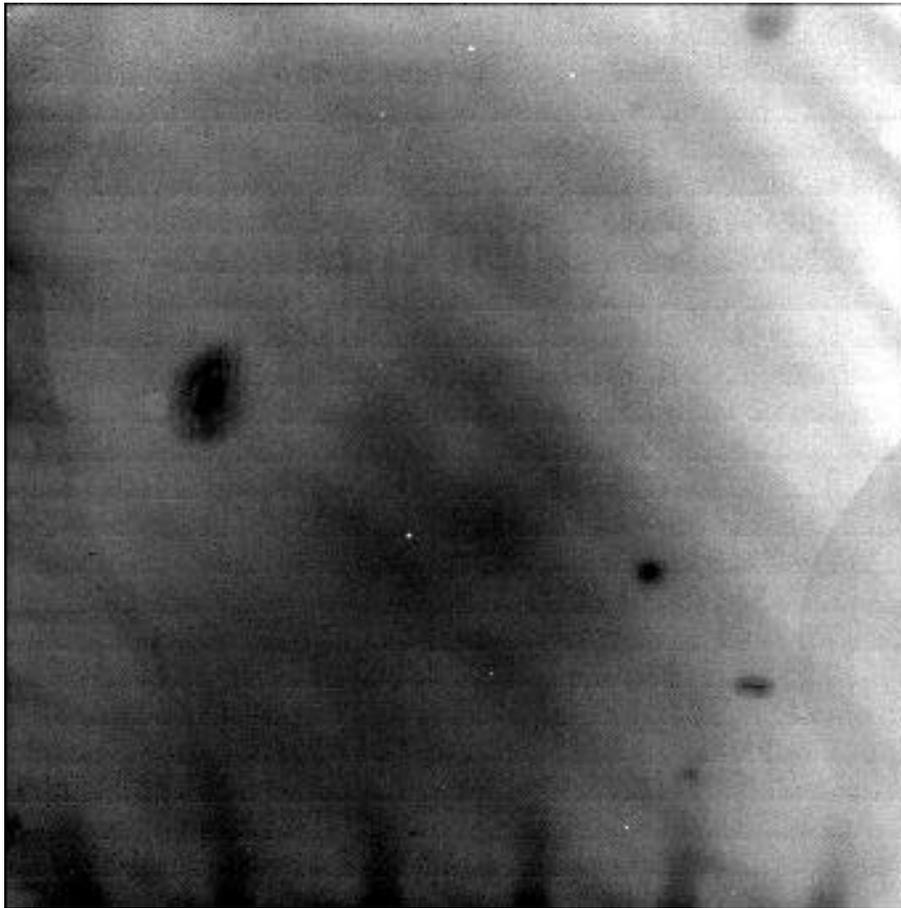
WAC FM flat field images taken during the Light Transfer Curve (LTC) calibration test exhibited interference fringes in various filter combinations. The diagonal direction of the fringe remained the same throughout the various images, indicating that perhaps the interference was caused subsequent to the filters in the optical path. One theory proposed a possible wedge in the CCD window. Another puzzling observation was made noting the vertical interference fringes seen at the bottom of the CL1/VIO and CL1/BL1 images. No definite explanation is available at this time.
